Tillamook Bay and Estuary, Oregon General Investigation Feasibility Report

APPENDIX D

Fluvial Geomorphic Analysis of the Tillamook Bay Basin Rivers

March 2002

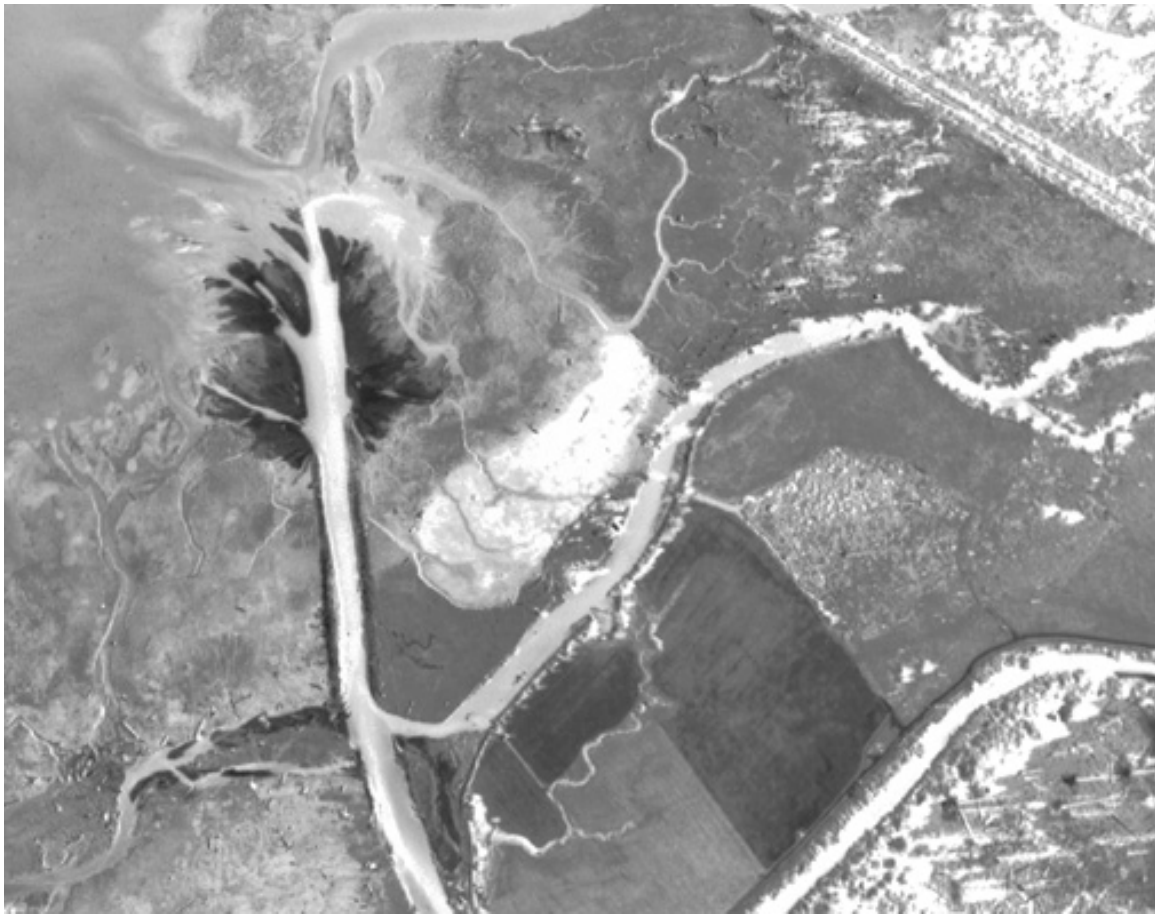
Photograph Number 1: Kilchis River 1939; River mile 0-1.

Large sediment deposit at the river – delta interface, it is still visible on the 2000 Photograph. The presents of the sedimentary element are an indication that recent sediment rates have slowed.

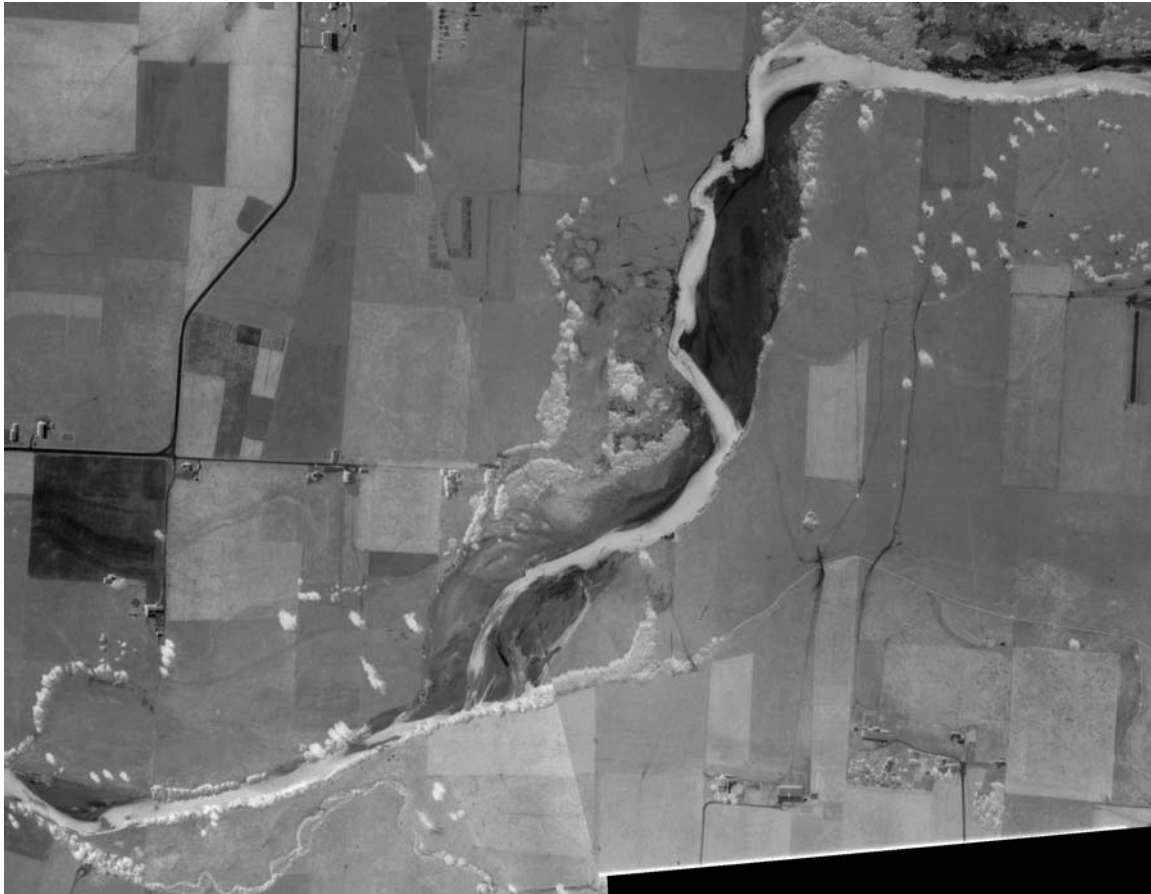
Photography Number 3: Trask River 1939; River mile 6 –7.

Extensive Gravel Bar complexes with limited riparian development. Gravel deposition occurring resulting in bed aggradation. High sediment loading associated with basin fire history

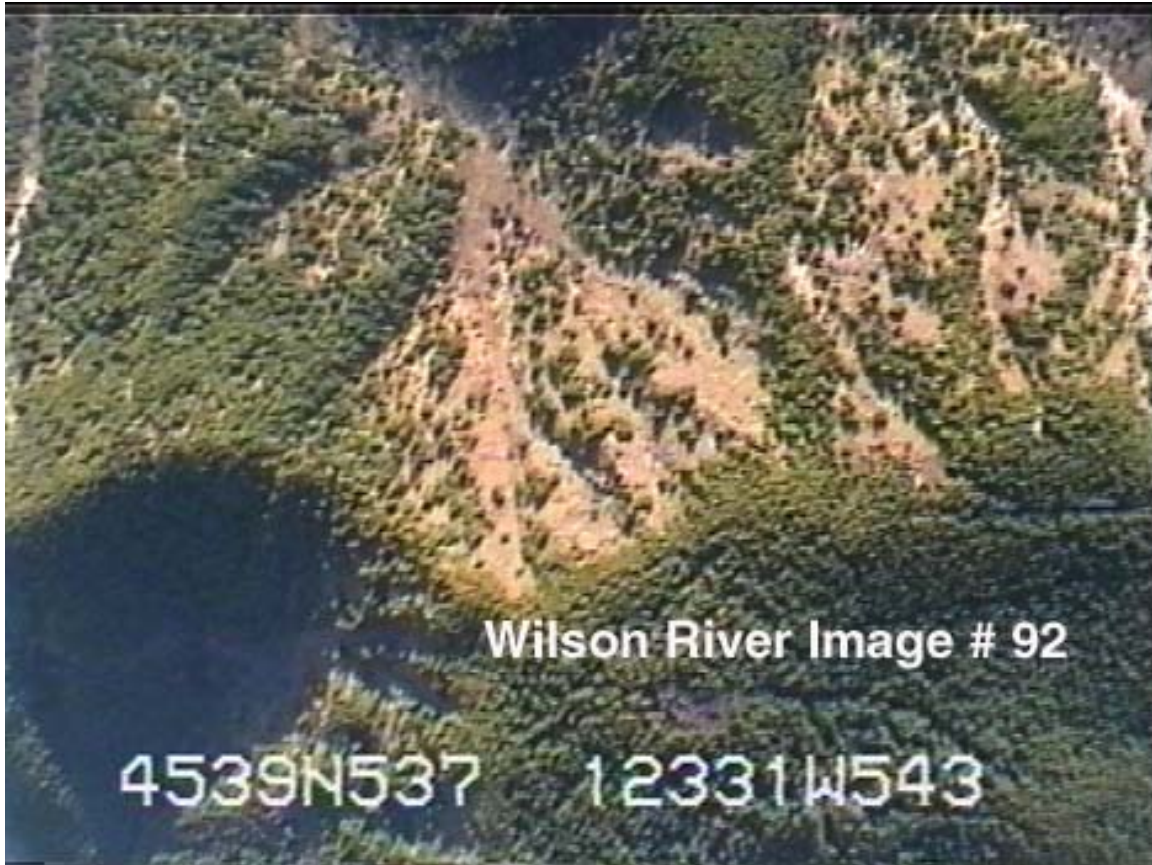
Photography Number 4: Wilson River November 1999.

Upper Basin Area; illustrating the slope Failures in the Upper Wilson Basin resulting from the November 1999 winter. (Wilson River Image 92)

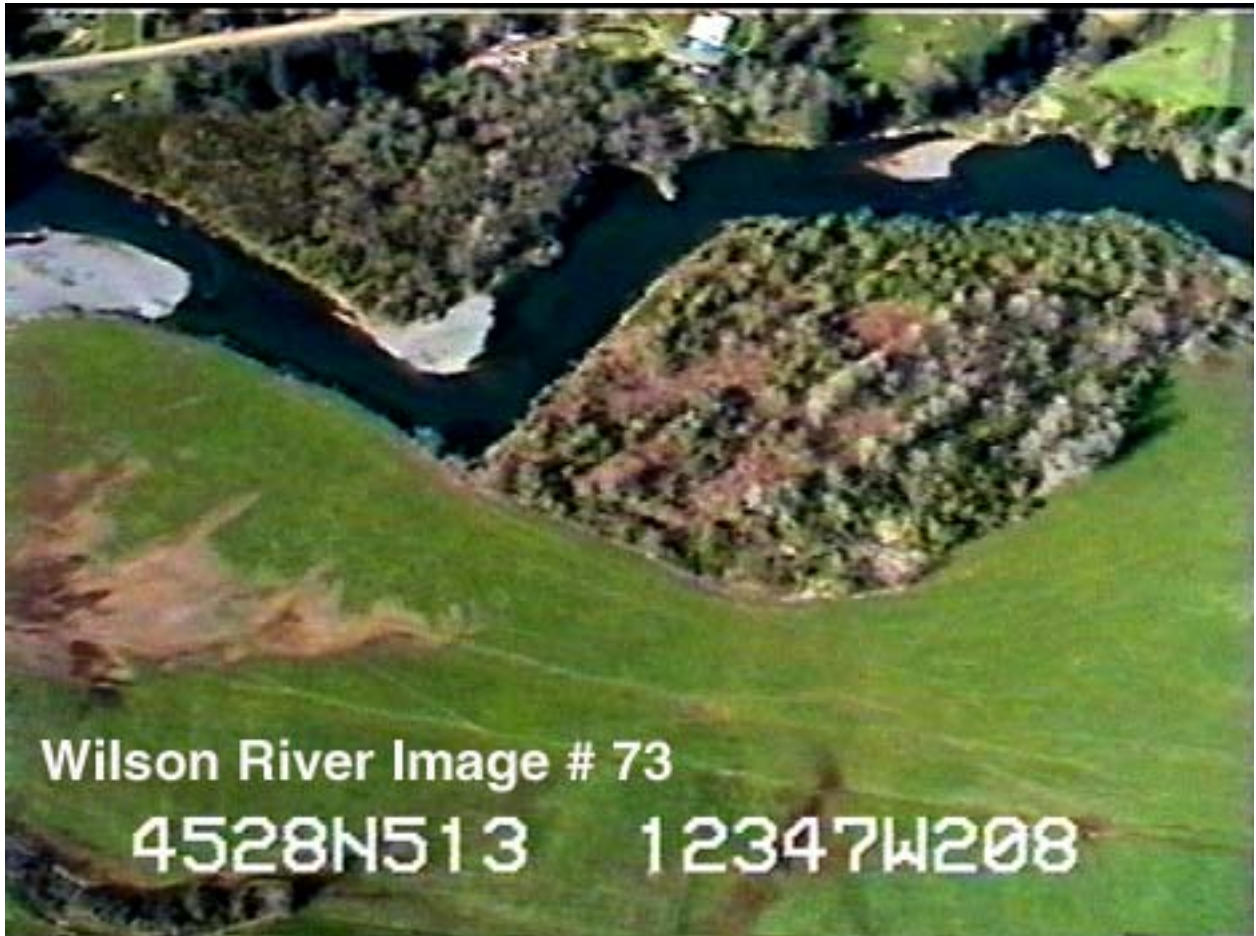
Photography Number 6: Wilson River November 1999, Middle Alluvial Plain.

Fine grain sediment deposited on agricultural land after flood event. Notice the large riparian zone and minor gravel bar complexes.
(Wilson River Image 73)

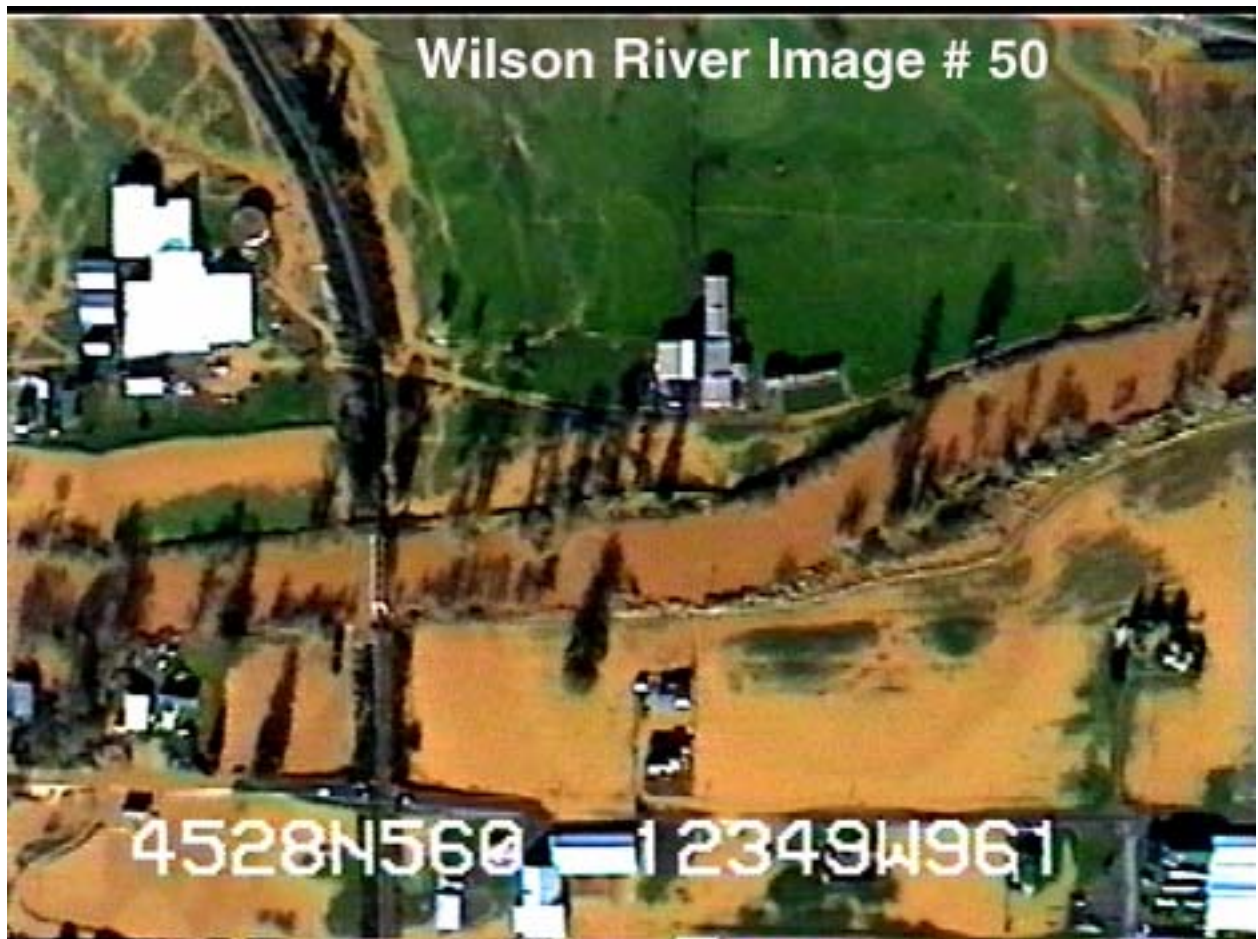
Photography Number 7: Wilson River.

Alluvial Plain at Flood Stage and Out of Channel Flow.
(Wilson River Image 50)

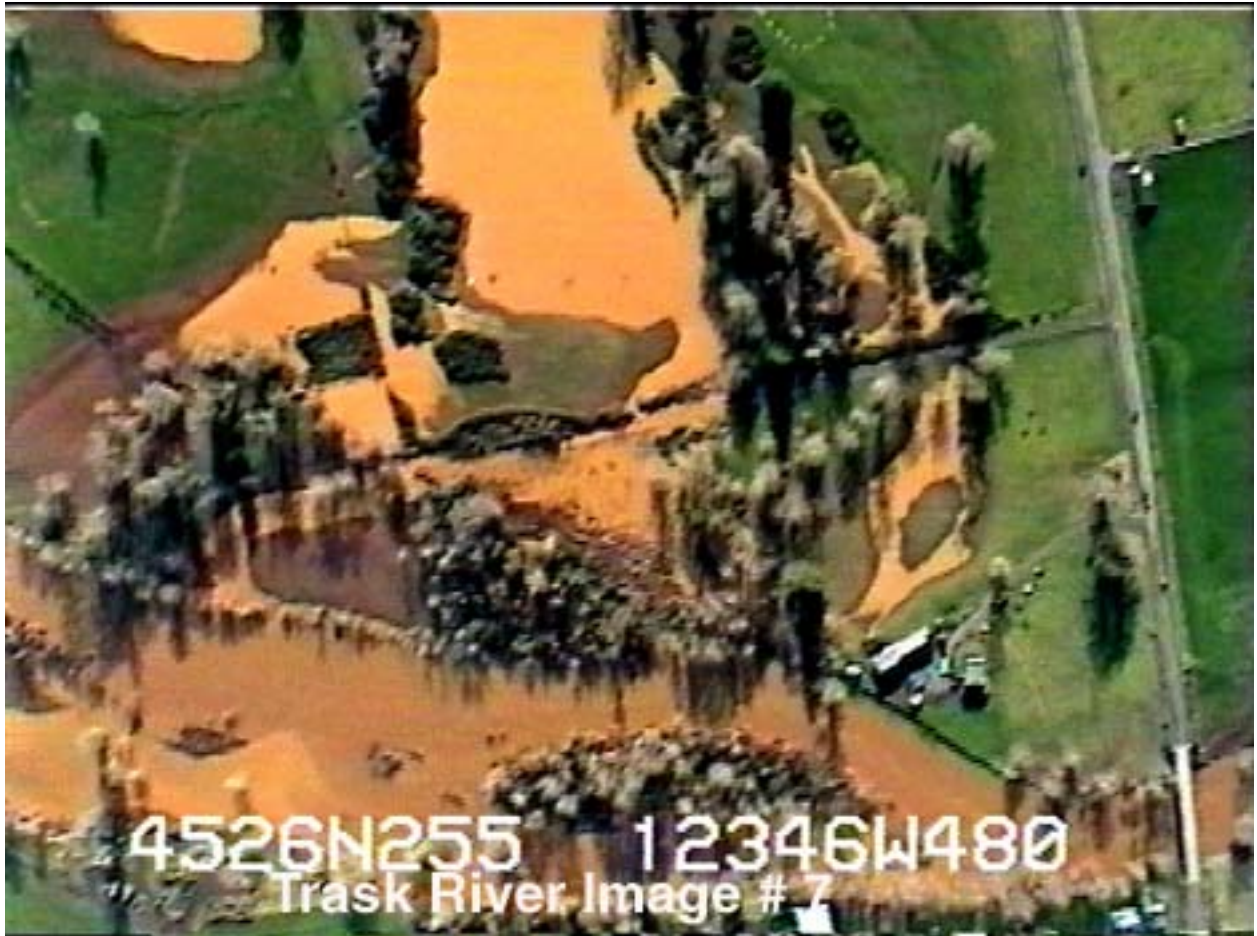
Photography Number 8: Trask River November 1999.

Lower Alluvial Plain at Flood Stage and Out of Channel Flow. (Trask River Image 7)

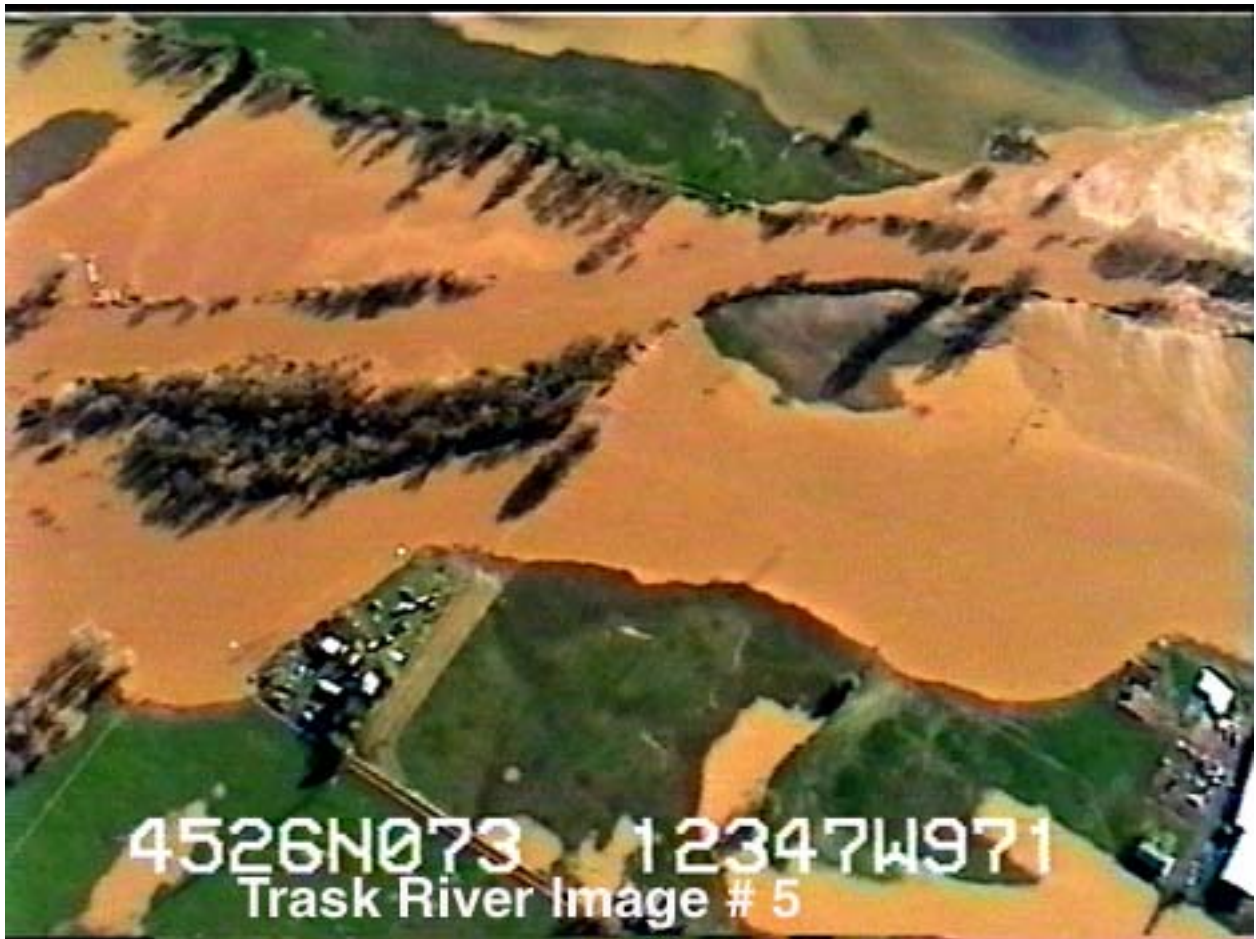
Photography Number 9: Trask River November 1999.

Upper Alluvial Plain at Flood Stage and Out of Channel Flow. Fine grain sediments are depositing on the agricultural lands. (Trask River Image 5)
